## Project Case Study: Windshield Seal

Extruded and spliced rubber seal

Military vehicle windshield sealing component

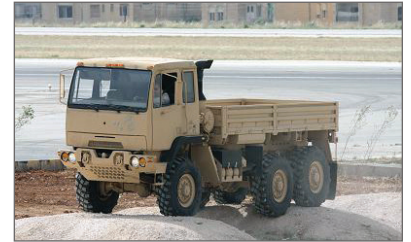
After review, Longwood engineers determined that the existing seal design caused many of the production issues. The seal manufacturing process used multiple steps and was made with molded corners bonded to two different extruded profiles. Because of the complex design and multiple steps, the seal size varied significantly. Our engineers also recognized that the rubber material being used was too stiff for the application.

Longwood formulated a new rubber compound with a lower modulus to increase material flexibility, the profile was redesigned for consistency, the seal was made with a single piece and splice design and the seal circumference size was reduced. With these changes, the new seal allowed the profile to form to the truck windshield shape without molded corners and the extension of the seal lip allowed for enhanced sealing capability. The redesigned single-piece seal surpassed all weathering and vigorous field test requirements and was approved by the US Army. The results to our customer was a 30% reduction in part cost, decreased installation times by removing unnecessary steps, and the elimination of scrap during installation.
